Lessons from Katrina

Despite differences in flow velocity and inundation duration, the effects on the coastal infrastructure in the inundation zones of Hurricane Katrina and the Indian Ocean tsunami of December 2004 were remarkably similar. Surveying the effects of Hurricane Katrina will no doubt assist in the ongoing study of tsunami loading on coastal construction. **By Ian N. Robertson, Ph.D., S.E., M.ASCE, H. Ronald Riggs, Ph.D., P.E., M.ASCE, Solomon Yim, Ph.D., M.ASCE, and Yin Lu Young, Ph.D., M.ASCE**

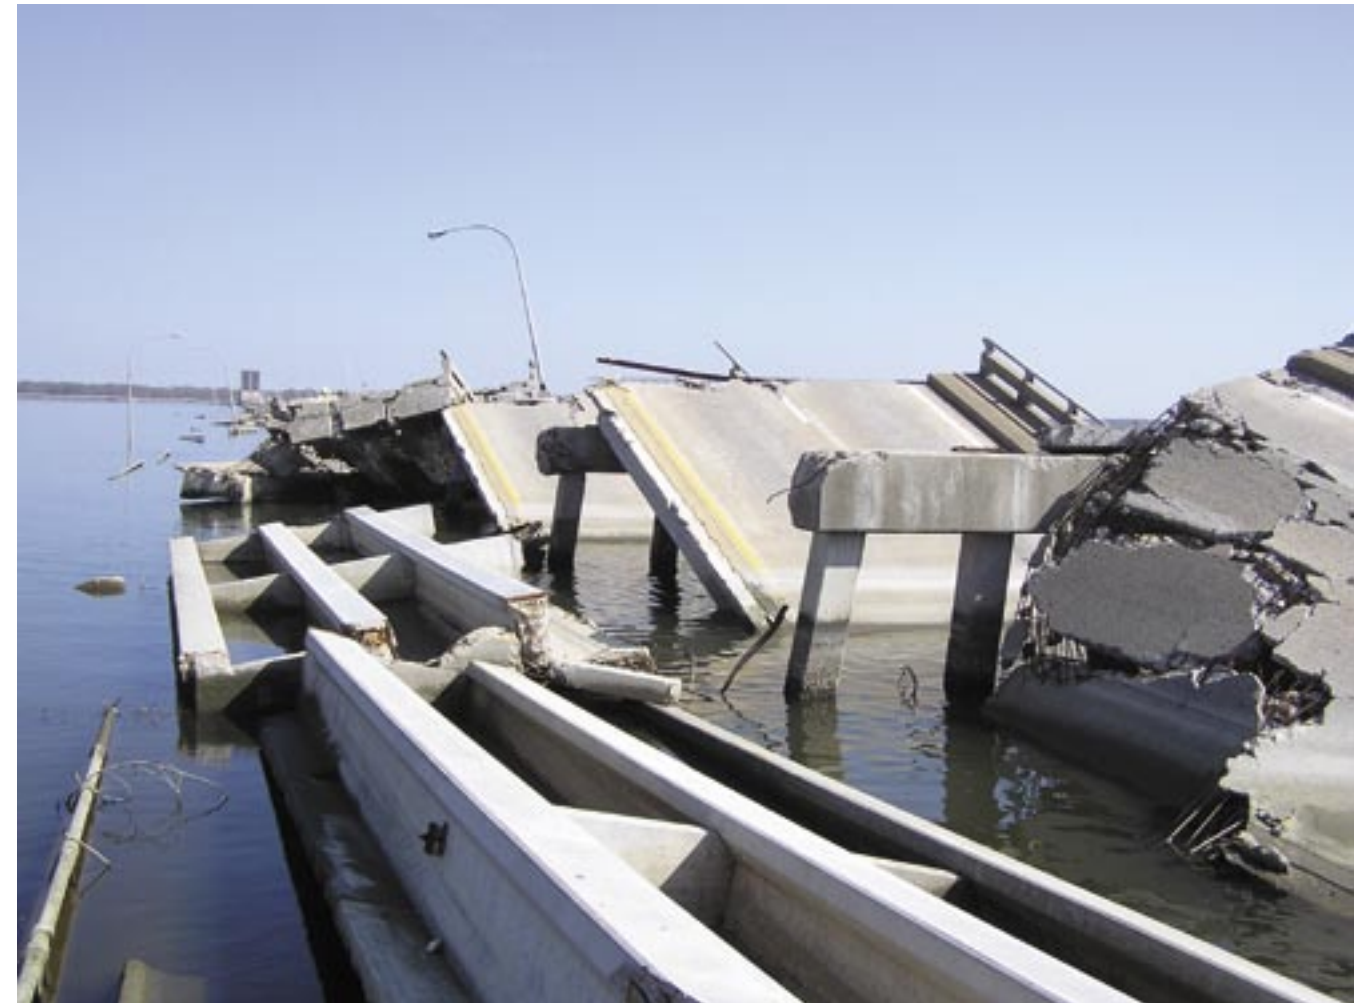
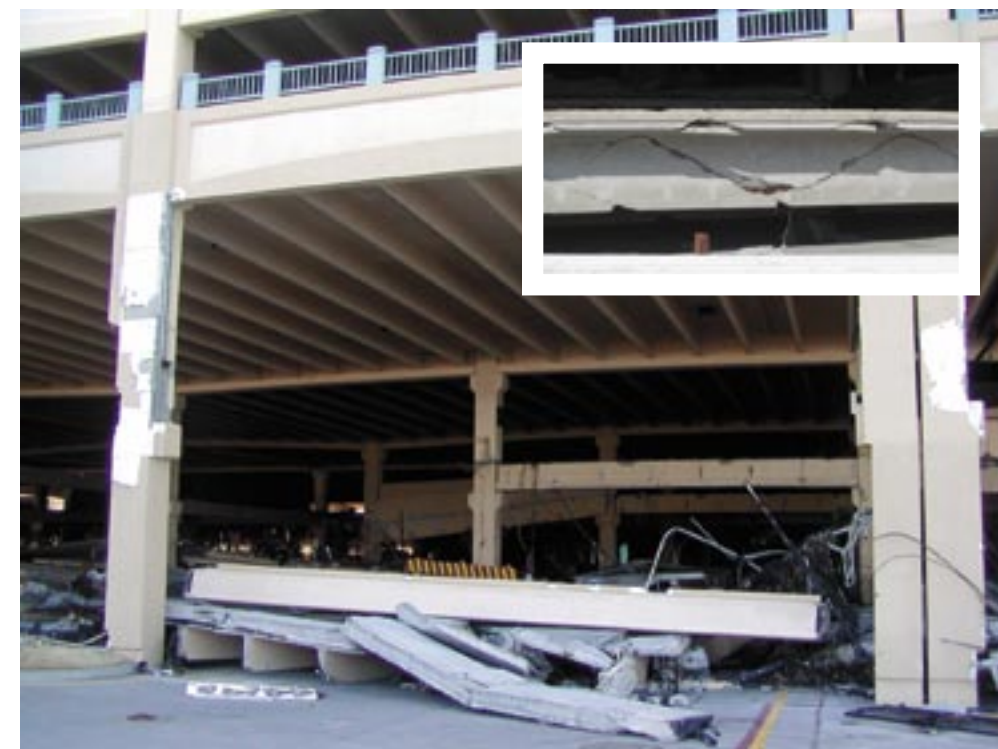
The highway bridge on U.S. 90 in Mississippi from Biloxi to Ocean Springs was nearly demolished by the storm surge, *above*. An inverted segment of the bridge displays the volume of air probably trapped below the bridge deck, contributing to the buoyancy of the bridge segments. The complete collapse of the second level of a precast-concrete parking structure in Biloxi, *left*, was the result of buoyancy induced by trapped air. The negative bending moments induced by this uplift—combined with the prestress tendon forces—caused compression failure of the thin web sections at midspan of the precast double Ts, *inset*.

The bridge on U.S. 90 in Mississippi between Biloxi and Ocean Springs is composed of simply supported 45 ft (13.7 m) bridge segments, each consisting of six prestressed-concrete girders supporting half of the roadway deck and one sidewalk. The air trapped between the girders, along with the reduction in self-weight caused by submersion in seawater, meant that these segments were buoyant when fully submerged. The bearings supporting each end of the girders at the pier bents provided no restraint against uplift and only nominal resistance against lateral movement. Because it is in a zone of low seismic activity, there were

no requirements for shear keys to provide lateral restraint or for ties to prevent uplift, requirements that are common in seismic regions. Friction induced by gravity load—and small, ½ in. (12.7 mm) thick steel angles—were the only lateral restraints for these bridge segments. Once buoyant, the segments were free to move off their supports under the lateral load from surge and wave action. Apart from the bridge segments elevated over the ship channel, every segment of this bridge was dislocated from its supports and collapsed into the bay.

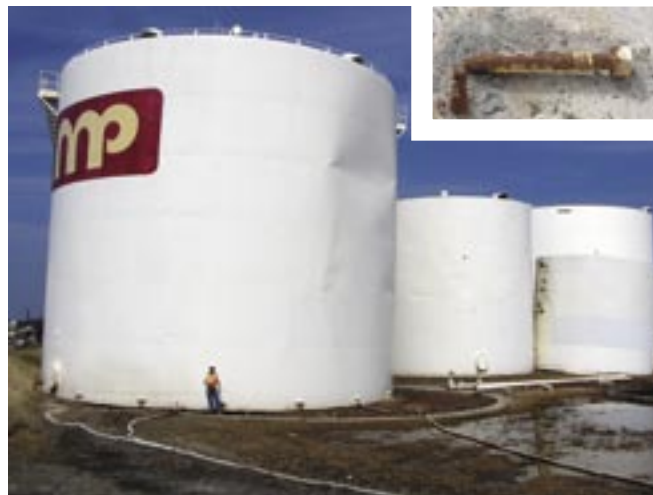
The storm surge exceeded the elevation of the containment berm surrounding a series of fuel storage tanks at Rhodes Point, in Biloxi, Mississippi. Buoyancy of the empty or partially empty tanks resulted in failure of the corroded anchor bolts, inset.

Buoyancy also resulted in the relocation of a number of storage containers that were inadequately restrained against uplift. Lack of adequate restraint and deterioration of hold-down bolts as a result of corrosion were common factors in the uplift failure of empty or partially empty storage tanks, cement silos, and similar steel structures.

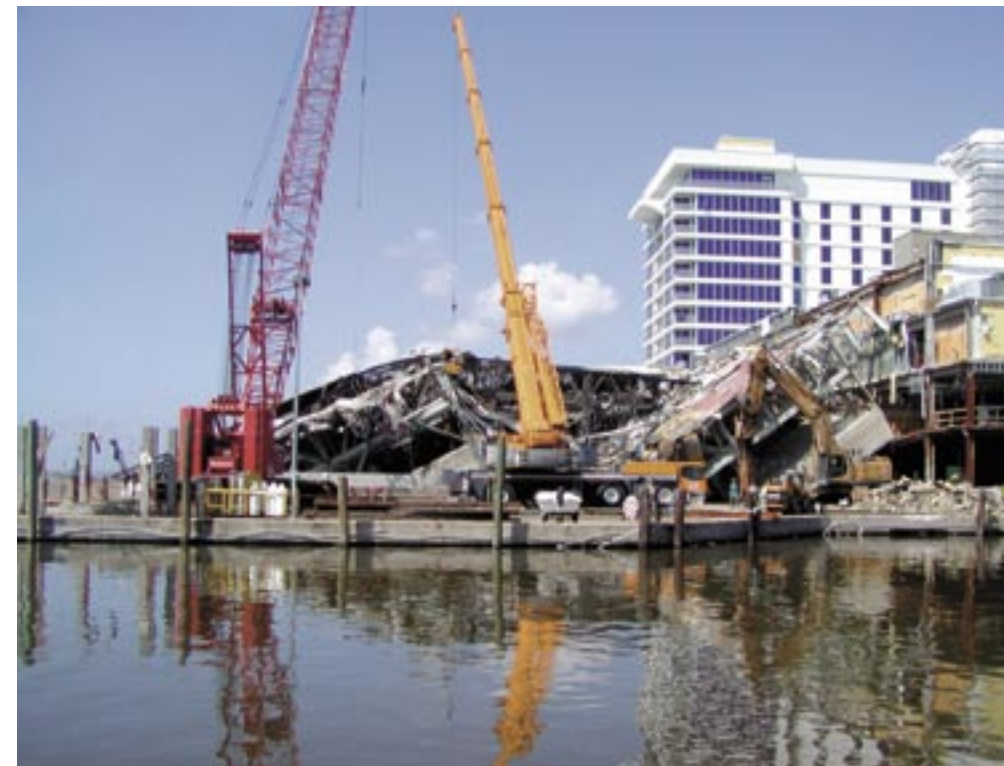
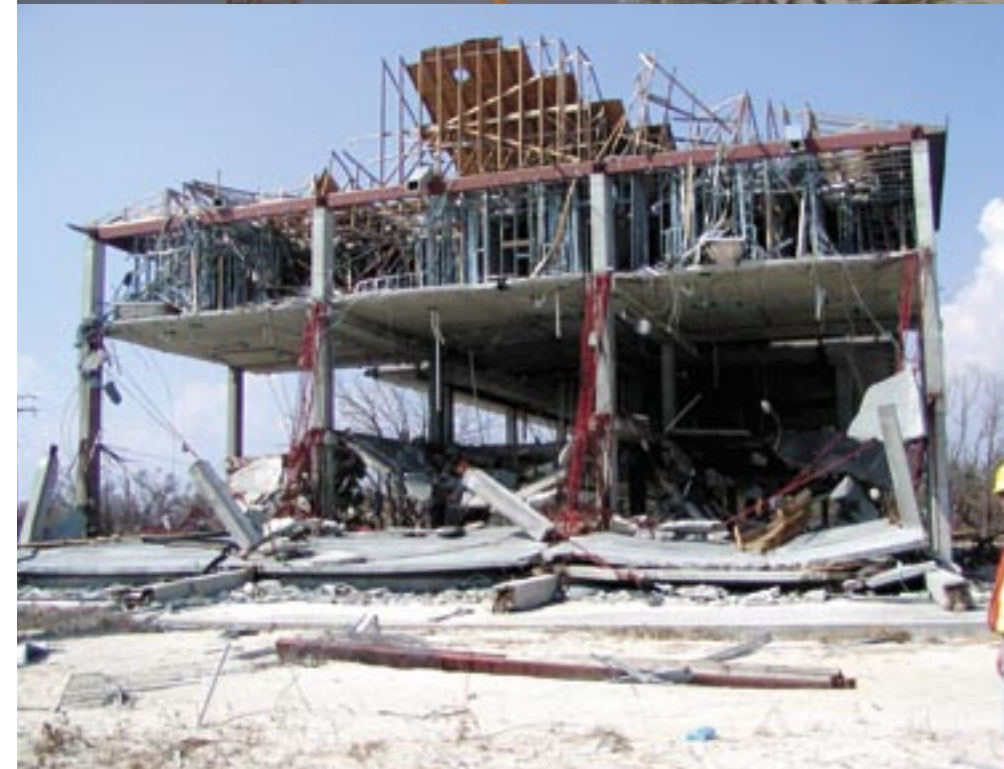
The casino of the Hard Rock Hotel & Casino Biloxi was built on floating pontoons enclosed in a fixed exterior structure. Collapse of the entire structure, top, is thought to have resulted from pounding between the pontoons and the inland columns supporting the exterior structure. Hydrodynamic uplift of the posttensioned flat slab in the bay closest to the shoreline appears to have initiated the frame collapse of a concrete building frame under construction on U.S. 90 in Pass Christian, Mississippi, above.

The Hard Rock casino was located on floating barges and was enclosed in a fixed "shell," which presumably was designed to resist wind loads. The exterior shell collapsed onto the casino, virtually demolishing it. This casino was the most severely damaged of all the casinos surveyed. Three possible failure mechanisms can be discerned. First, excessive vertical motion of the barges could have exceeded the clearance between the casino and the fixed roof, inducing collapse. The surge was probably at least 20 ft (6.1 m), and this may not have been accommodated in the design. A second scenario is that the roll induced by the incoming surge and waves caused the top part of the casino to impact the columns of the shell, resulting in progressive collapse. However, the most likely explanation is that the surge and waves elevated and pushed the barges inland, causing the inland columns of the exterior shell to collapse, which in turn caused progressive collapse of the entire system.

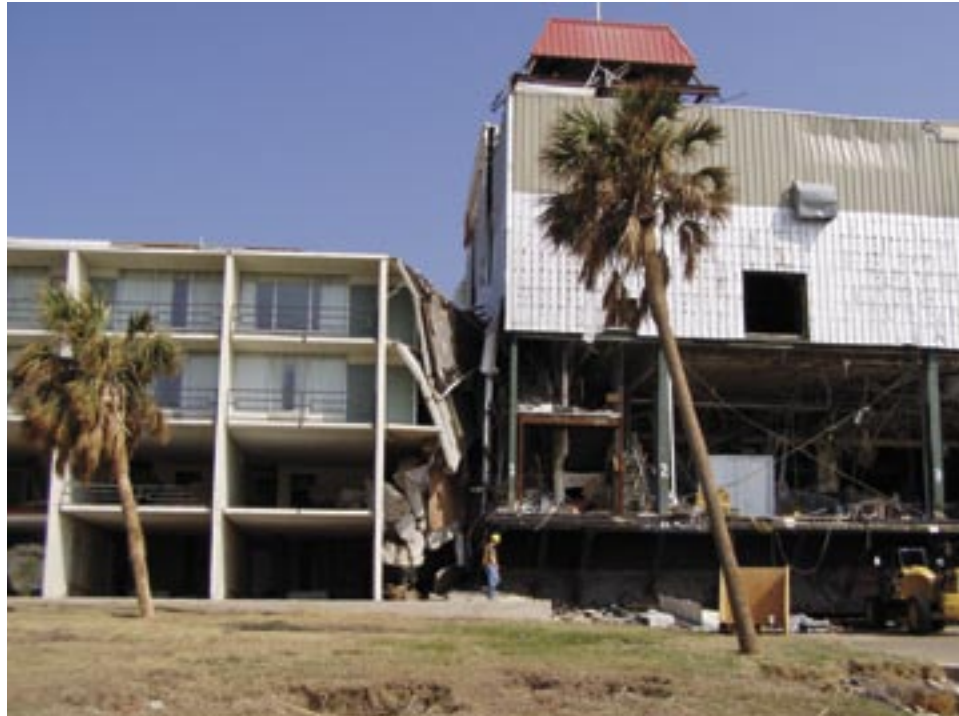
The partial collapse of the four-story reinforced-concrete Oakmont apartment building in Biloxi, Mississippi, *right*, resulted from the impact of a barge-mounted casino that broke free from the Biloxi President Casino some 3,609 ft (1,100 m) east of this site. Scour to a depth of 15 ft (4.6 m) occurred around the abutment in Bay St. Louis, Mississippi, of the U.S. 90 bridge to Pass Christian, Mississippi. Liquefaction-induced scour may have contributed to the failure of the concrete apron intended to protect the backfill, allowing shear-induced scour around the abutment and piles and below the approach roadway, *below right*.

An example of impact is clearly demonstrated by the collision between the barge of the Biloxi President Casino and the Oakmont apartment building in Biloxi. The considerable mass of this barge—at only a modest speed—will impose a large force on any structure it impacts. Little evidence was found of significant debris impact damage to major engineered structures other than from such large floating structures as barges.

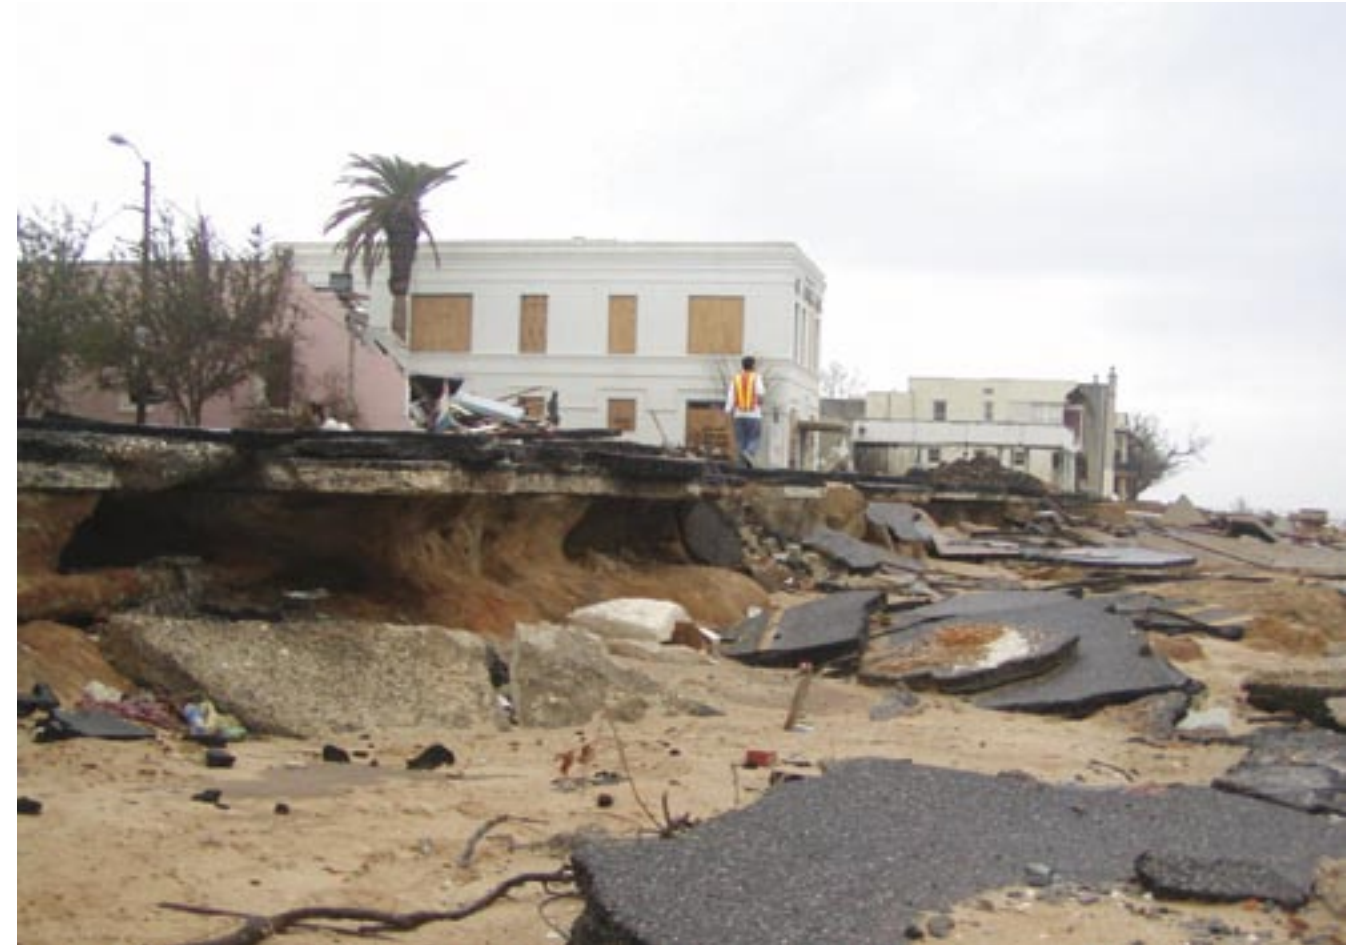
The complete failure of North Beach Boulevard—the coastal highway through Bay St. Louis, Mississippi—was due to a combination of liquefaction and shear-induced scour.

Wave-induced liquefaction is also believed to be responsible for the scour under ground-floor slabs and highway subgrades. The thin floor slab or highway pavement helps to prevent current-induced scour and postpone the point at which liquefaction occurs. Nevertheless, the supporting sandy soil or backfill is still susceptible to liquefaction-induced scour, particularly during wave drawdown or ebb surge. Once the supporting soil liquefies, the thin floor slab or highway pavement will collapse, which can lead to total collapse of the structure.

Numerous examples of liquefaction-induced scour under floor slabs and footings were observed throughout the Mississippi coastline. Craters similar to sinkholes were observed in many locations along the coastal highways as a result of drawdown and wave-induced liquefaction of the subgrade below the pavement. The most extensive scour observed along the Mississippi coastline was at the western abutment of the bridge on U.S. 90 in the town of Bay St. Louis. The abutment was originally surrounded by a soil embankment protected by a retaining wall and a concrete apron. Massive scour of all backfill and sandy subsoil was observed below the collapsed embankment apron. The maximum scour depth was approximately 15 ft (4.6 m), and the scour extended behind the abutment wall and undermined the approach slabs by as much as 8 ft (2.4 m). Similarly, a combination of wave-induced liquefaction and shear-induced scour is believed to be responsible for the complete scour of North Beach Boulevard in Bay St. Louis, where the maximum scour depth was 5 to 6 ft (1.5 to 1.8 m). A number of residential and low-rise commercial buildings suffered foundation failure and partial collapse as a result of undermining by scour.
