Coastal Bridge Performance during Hurricane Katrina

ABSTRACT: The storm surge associated with Hurricane Katrina caused tremendous damage along the Gulf Coast in Louisiana, Mississippi and Alabama. Similar damage was observed subsequent to the Indian Ocean Tsunami of December 26, 2004. In order to gain a better understanding of the performance of engineered structures subjected to coastal inundation due to tsunami or hurricane storm surge, the authors surveyed damage to bridges, buildings and other coastal infrastructure subsequent to Hurricane Katrina. A number of coastal bridges experienced significant structural damage due to storm surge and wave action. Bridge decks submerged during the inundation were subjected to hydrodynamic uplift forces due to wave action and hydrostatic uplift forces due to buoyancy, enhanced by air trapped below the bridge deck. Inadequate performance of the deck-to-pier connections resulted in complete loss of all deck segments on a number of low level coastal bridges. Extensive scour was also observed around approach roadways and abutment foundation systems due to a combination of shear- and liquefaction-induced sediment transport.

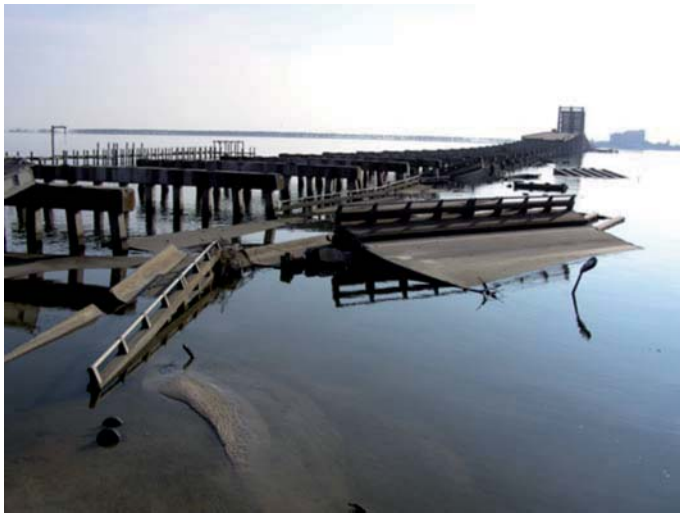
Figure 1. Deck damage on US90 bridge over Biloxi Bay.

acting on the trapped air will result in a slight decrease in the air volume. In addition, vertical and horizontal hydrodynamic loads induced by wave action were sufficient to dislocate these deck elements (Douglass et al. 2006) (Figure 1).

The bearings supporting each end of the girders at the pier bents provided no restraint against uplift, and only nominal resistance against lateral movement (Fig. 3). Being a low seismic zone, there were no requirements for shear keys to provide lateral restraint or ties to prevent uplift, as is common in seismic regions. Friction induced by gravity load, and small 12mm thick steel angles, were the only physical restraint against lateral movement for these bridge segments. When subjected to the wave-induced hydrodynamic uplift and/or buoyancy effects, the segments were free to move off their supports under the lateral load from surge and wave action. Apart from the bridge segments elevated over the ship channel, every segment of this bridge was dislocated from its supports and collapsed into the bay (Figure 1).

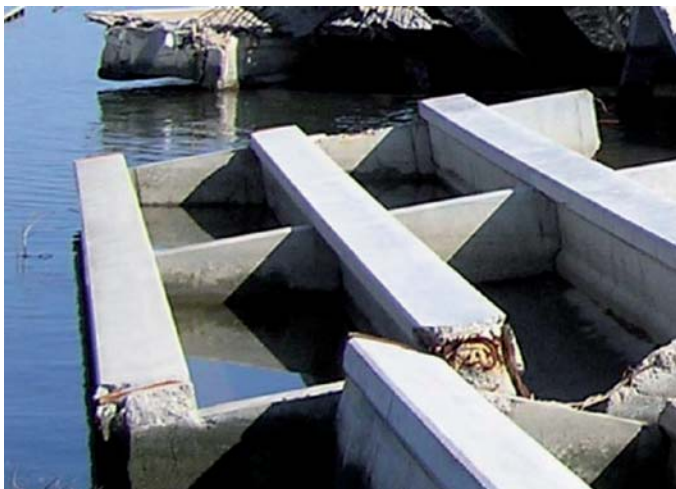
Figure 2. Inverted deck showing potential trapped air volume.

The US90 highway bridge over Biloxi Bay, between Biloxi and Ocean Springs, Mississippi, is composed of simply-supported bridge segments varying in length from 13.7 to 15.9 m. Each segment consists of six prestressed concrete girders supporting half of the roadway deck and one sidewalk. Hurricane Katrina storm surge at this bridge location was sufficient to submerge all low-level spans of this bridge (Fig. 1). When submerged, the air trapped between the girders, along with the reduction in self-weight due to submersion in sea-water, meant that these segments were very nearly buoyant once submerged (Fig. 2) (Robertson et al. 2006b). In the buoyancy calculations, air is assumed to fill the void under the bridge deck when the water level reaches the bottom of the end bulkheads. This volume of air is assumed trapped as the water level rises to submerge the entire deck section. Considering hydrostatic effects only, the water head

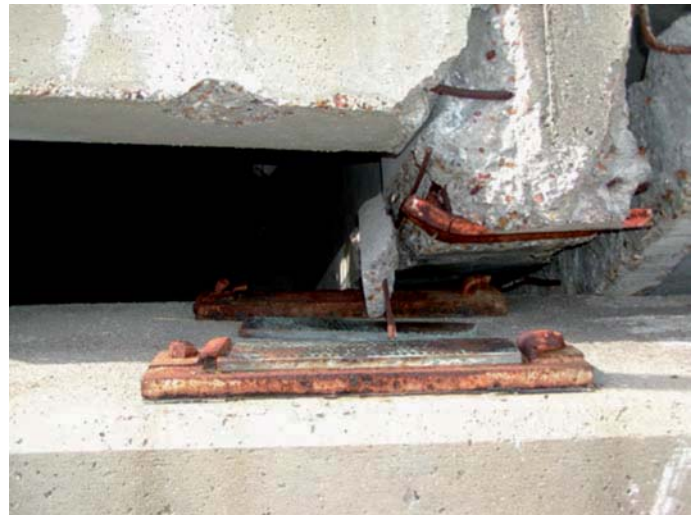
Figure 3. Friction bearing supporting US90 bridge girders.

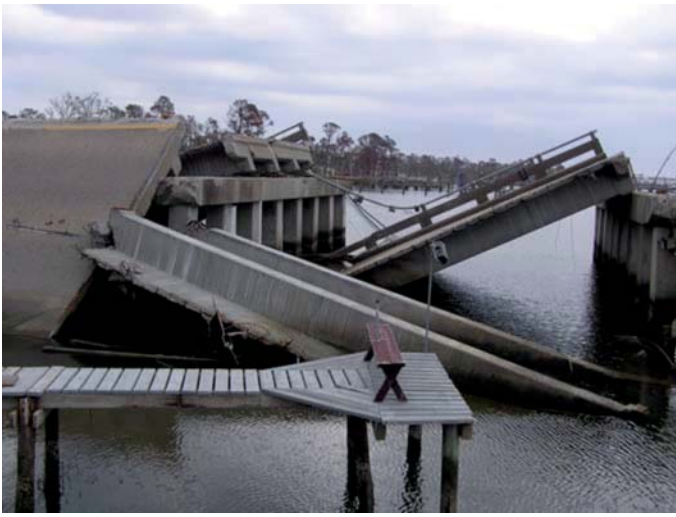
The US90 highway bridge across St. Louis Bay, between Pass Christian and Bay St. Louis, Mississippi, consists of simply-supported rectangular concrete girders supporting a concrete deck slab (Fig. 4). The bulkhead and bridging elements provided between the girders of this deck are only partial depth allowing much of the air below the deck to escape. Nevertheless, virtually every segment of this bridge was dislodged from the supporting piers. This failure is attributed to the combination of reduced self-weight due to buoyancy and the hydrodynamic uplift and lateral loads from surge and wave action, combined with the lack of restraint against uplift or lateral movement at the support bearings. Fig. 5 shows the rocker bearings at the ends of each span. The only restraint against lateral movement of the girders was the three small shear

Figure 4. Deck segments of US90 bridge at St. Louis Bay.

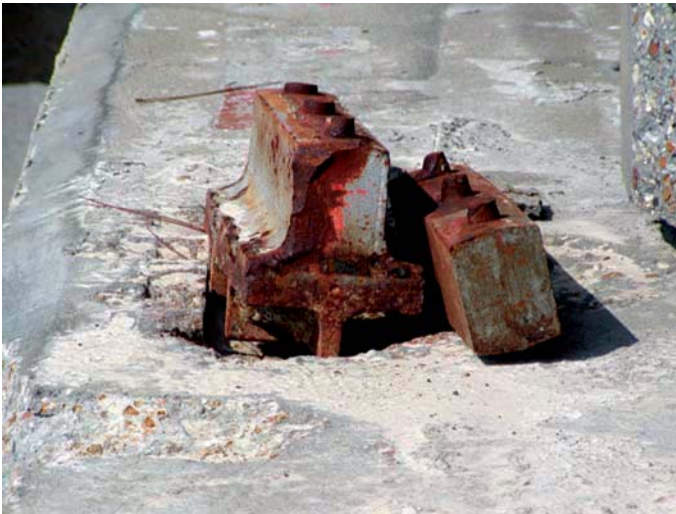
Figure 5. Bearing with limited lateral and no uplift restraint.

studs provided between the rocker and the bearing plate in the girder soffit.

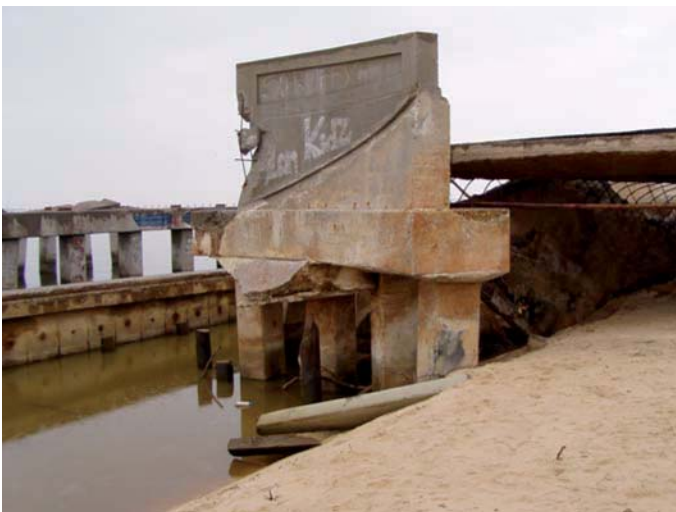
Significant scour was evident under the approach slabs and abutments at both ends of this bridge (Fig. 6). The embankments surrounding the abutment piles were originally covered with concrete slabs which had been completely removed by the storm surge. Exten-

Figure 6. Scour around abutment and under approach slab.

Two types of scour mechanism were identified: shear-induced scour due to pick up and transport of sediments by the flowing water and debris; and liquefaction-induced scour due to soil instability as a result of pore pressure gradients within the sediment bed (Robertson et al. 2006b).

- Bridge foundations and approach roadways must be designed to accommodate scour induced by the surge and wave action. Scour results both from shear-induced particulate transport, and liquefaction-induced soil flow.

- Backfill around foundations and under earth-supported slabs should be selected to avoid liquefaction during rapid drawdown. Soil stabilization could be considered to reduce or prevent both liquefaction and shear-induced scour.

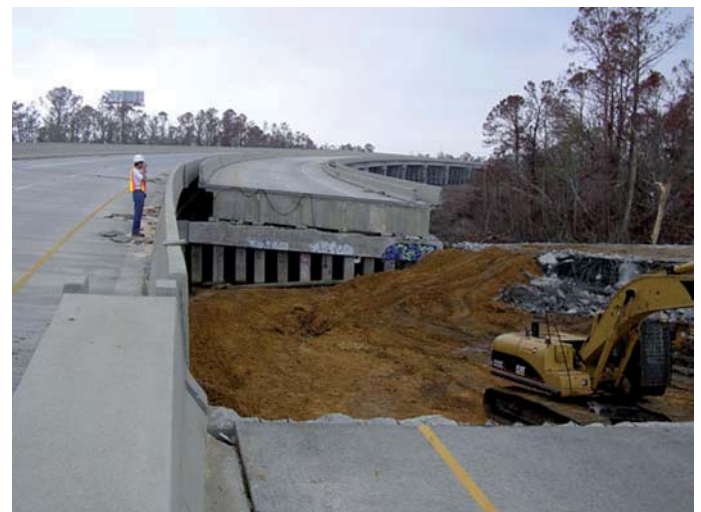
Long-span prestressed concrete bridge girders support the roadway forming the approach span to an elevated section of the US90 highway in Pass Christian, Mississippi. The first inland segment of this bridge was dislocated from its supports on the abutment and first pier bent (Fig. 7). This was the lowest segment on the bridge and although the extent of submersion by the storm surge is not known precisely, it is suspected that the large volume of air potentially trapped between the deep bridge girders resulted in significant uplift (Fig. 8). The limited reinforcing steel dowels between the bridge bent and the bulkheads at one end of the span were clearly not adequate to restrain the uplift forces and prevent dislocation of the segment (Fig. 9).

Figure 7. Single span of US90 washed from supports.

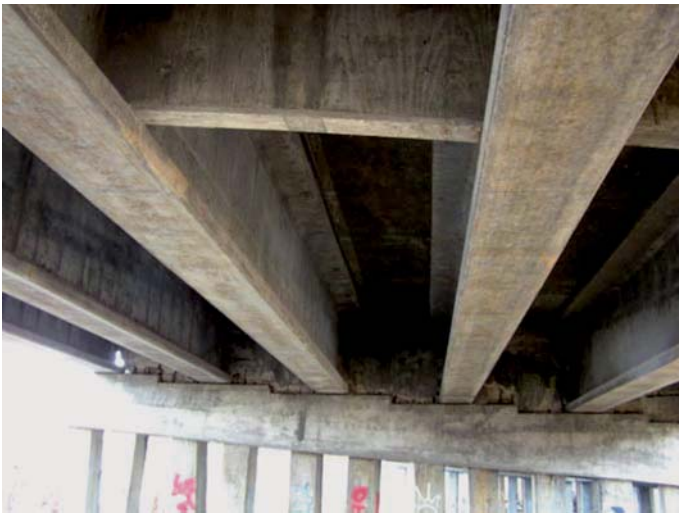
Figure 8. Soffit of US90 span showing potential trapped air volume.

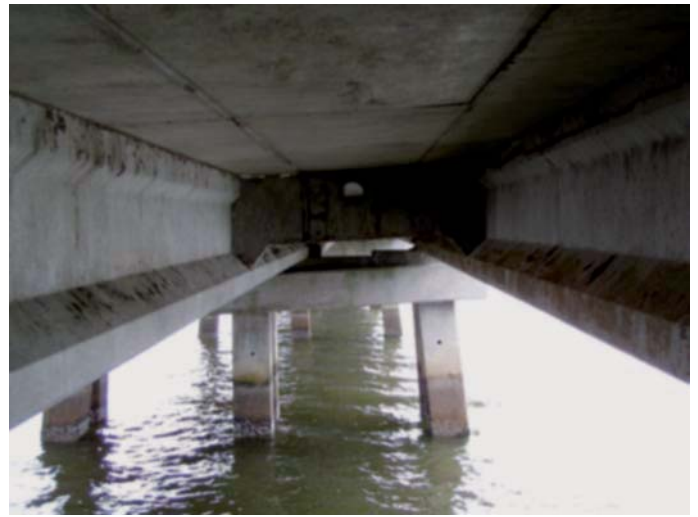
Figure 11. Reduced bridging and holes to allow airflow.

through the bridging and bulkheads to allow air to escape (Fig. 11). Although these measures may have helped during the slow water level rise induced by hurricane storm surge, they will likely be less effective during the rapid inundation caused by a tsunami.

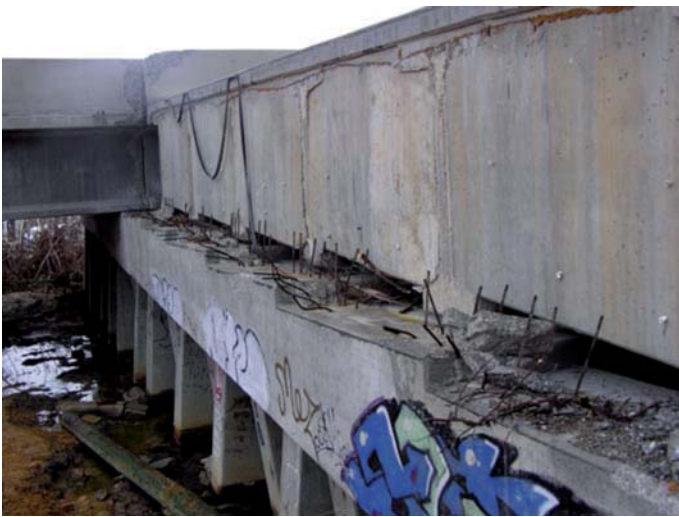
Figure 9. Inadequate dowels at bent support.

- Deck segments of low-level bridges in regions subject to coastal inundation should be restrained against uplift and provided with shear keys designed to resist all anticipated lateral loads. No reliance should be placed on the effect of gravity induced friction to restrain movement of the deck segments.

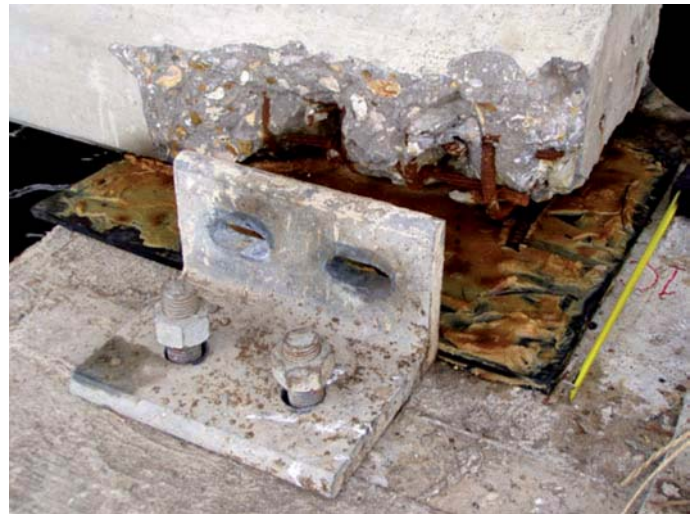
Figure 12. Failure of restraint due to anchor bolt pull-out.

This bridge was provided with steel angle restraints on either side of each exterior girder at each support bent (Fig. 12). Unfortunately, the capacity of these restraints was limited by the failure of the anchor bolts embedded in the bridge girders (Figure 12) and spalling of the concrete around the anchor bolts embedded in the supporting bridge bents (Fig. 13).

A properly designed restraint system such as that shown in Figures 12 through 14 could be used to retrofit existing bridges for future tsunami or storm surge inundation. However, better detailing and attention to quality of construction are required to prevent the failures noted in these figures.

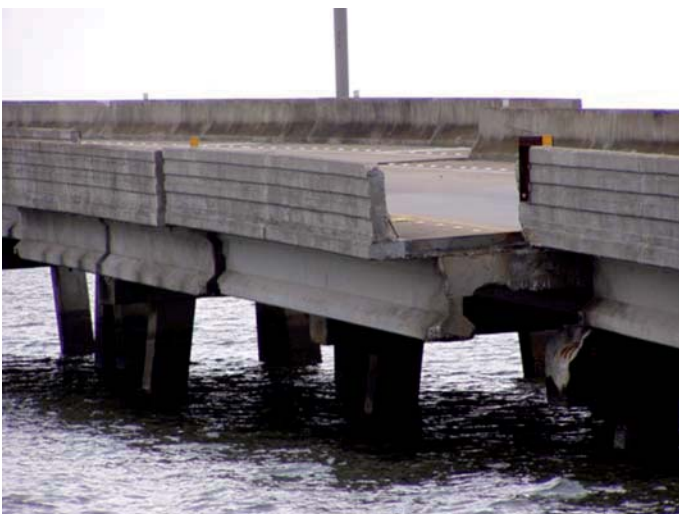
The I-10 onramp in Mobile, Alabama, was some distance from the main storm surge caused by Hurricane Katrina. Nevertheless, five segments of this bridge were dislocated from their supports (Fig. 10). It appears that the curvature of the bridge allowed for wedging of the segments, thereby preventing their complete collapse into the bay. Apparently efforts had been made to reduce the effect of entrapped air through reduction of the bridging depth and provision of holes

Figure 10. Dislocated segments of I-10 onramp, Mobile, AL.

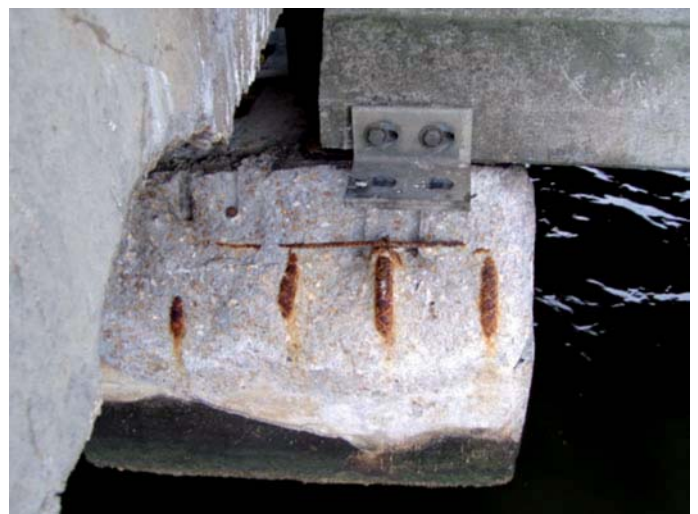
Figure 13. Failure of restraint due to anchor bolt edge spall.

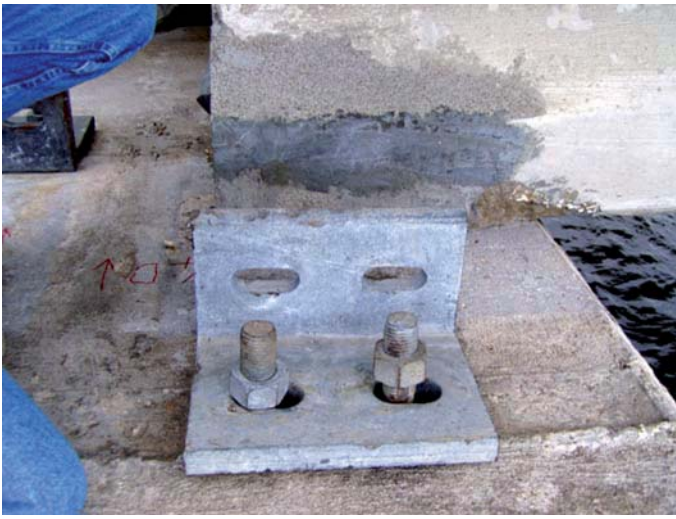
Figure 14. Anchor bolts missing from restraint angle.

In addition, a number of the restraint angles appeared to have been installed incorrectly. Fig. 14 shows a location where the horizontal anchor bolts had not been installed into the bottom of the bridge girder, possibly because of misalignment of the inserts. Fig. 15 shows the poor performance of a restraint angle where the bolt holes had been enlarged by flame cutting, presumably to accommodate anchor bolt misalignment.

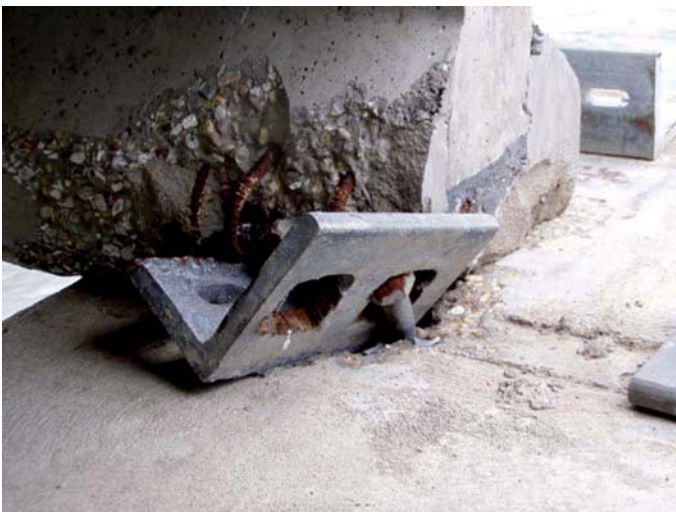
Figure 15. Failure of restraint due to flame cut oversized hole.

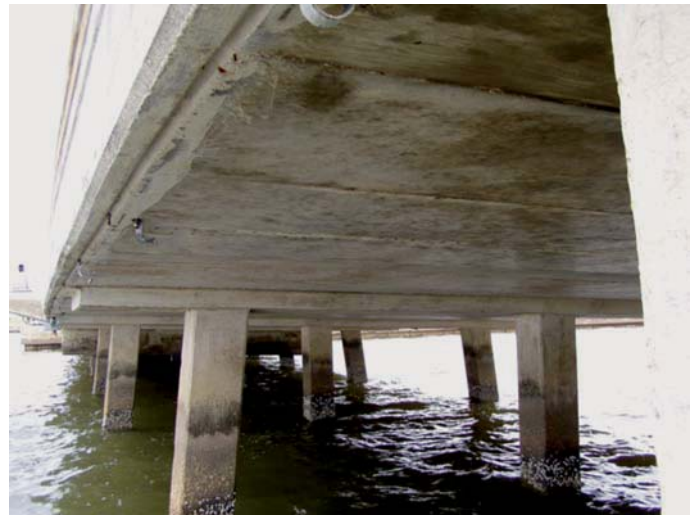
Figure 16. Undamaged bridge deck cast integral with support piles.

ple, the piles supporting a cast-in-place section of the I-10 onramp adjacent to the damaged spans suffered no visible damage during Hurricane Katrina (Fig. 16).

When considering a retrofit which results in strengthening the connection between bridge decks and supporting pier bents, it is also important to consider the supporting foundation capacity. During future inundation, the increased loads on the pier bent may overload the existing foundation system. However, the conservatism in foundation design will often accommodate these increased loads. For exam-

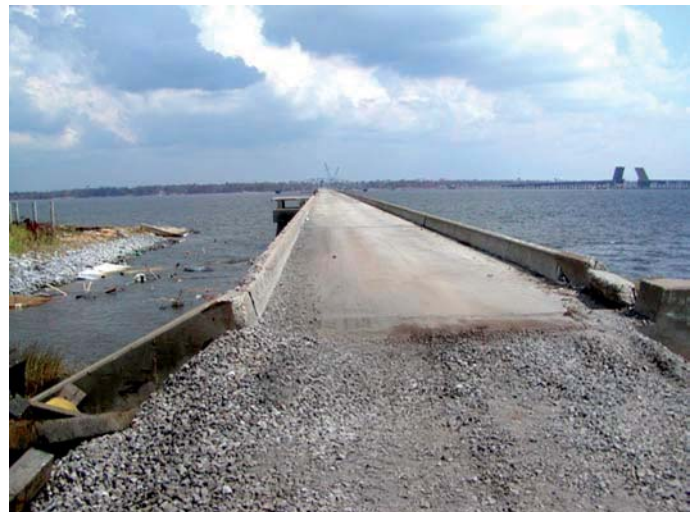
A notable exception to the poor performance of low-level bridge structures was the railroad bridge over Biloxi Bay (Fig. 17). Although the entire railway tracks, sleepers and ballast were swept into the bay, the prestressed concrete bridge girders and deck remained intact. The superior performance of this structure is attributed to the reduced hydrodynamic uplift due to the small width of the bridge deck and the relatively small volume of entrapped air because of the closely spaced girders (Fig. 18) (Robertson et al. 2006b).

Figure 17. Railroad bridge over Biloxi Bay, Mississippi.

a single segment of this bridge collapsed although it was subjected to the same storm surge and wave action that destroyed the adjacent US90 highway bridge described above.

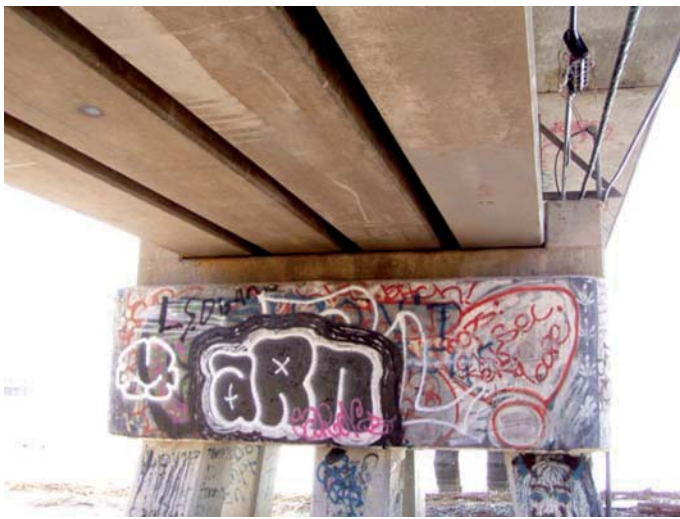
In addition, the superior lateral restraint provided by 380mm high concrete shear keys on either side of the girders at each support pier (Figure 18) was sufficient to resist the lateral hydrodynamic loads. Not

Figure 18. Large concrete shear keys on either side of closely spaced railroad bridge girders.
